Med-EcoSuRe Mediterranean University as Catalyst for Eco Sustainable Renovation

Energy Audit: Data collection and recommendations

Institute: Università degli Studi di Firenze – UNIFI

Building complex: Architecture Faculty building complex of Santa Verdiana

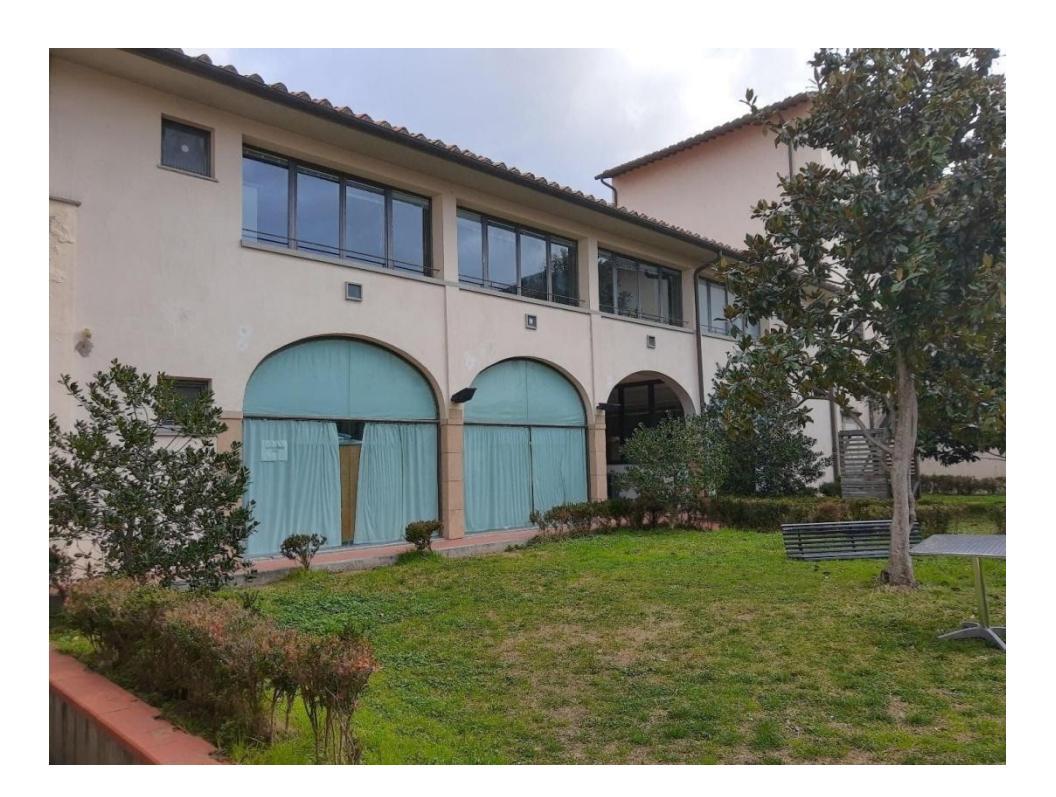
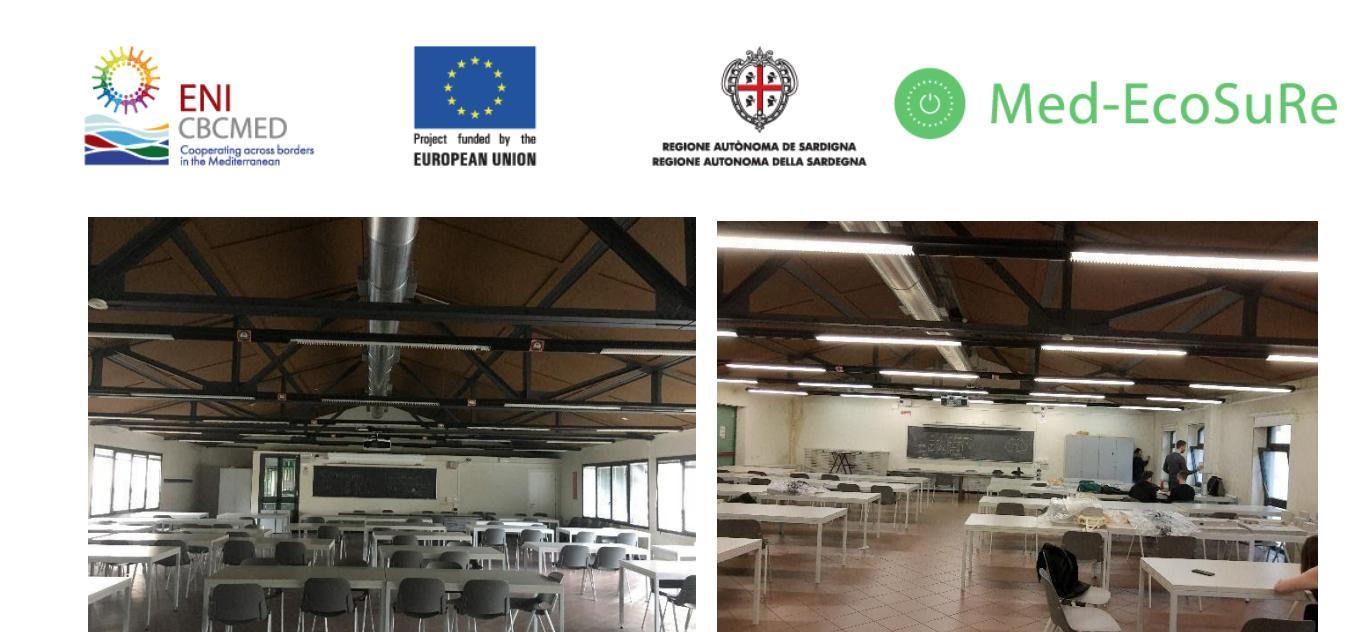
The rooms on the ground floor, less in the upper story, have a large amount of glazing exposed to the south that generates a greenhouse effect due to the radiation load gains. Circumstance that reveals critical from March to November, causing overheating inside the rooms. On the other hand, during the coldest days the large transparent components drive a major heat loss. Even in the presence of many windows there is no ventilation during winter enclosing poor air quality constantly, while in summer time the hot air coming from the outside determines uncomfortable conditions.

There are no shadings to protect from solar radiation, in the upper level semi transparent films have been applied to the glasses in order to control the glare effect.

In the interior of the spaces the lighting conditions are not ideal: in the lower level, there is too much light and in sunny days glare is a constant, while in the upper level natural lighting is quite low, specially in the central zone of the classroom, even if there is a sort of continuous façade in both south and north façades. Fluorescent lighting has to be turned on, during day hours, to achieve adequate lighting levels.

- Find and introduce a way to control direct solar radiation in accordance with the exterior climate conditions;
- Changing existing windows with double glass and thermal break frame windows;

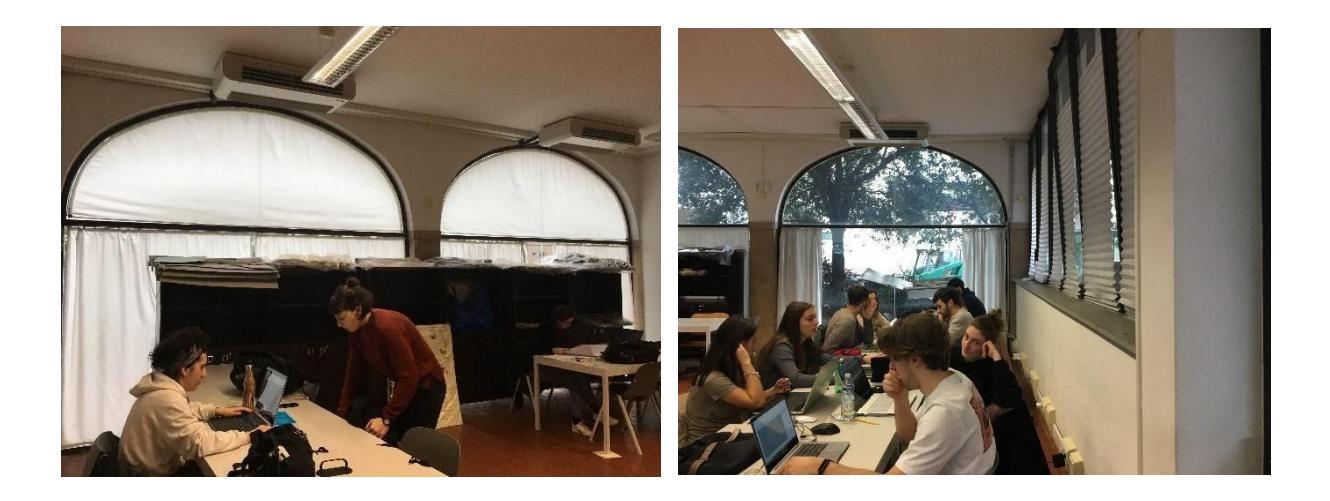
These rooms are part of the few areas of the entire complex that have an electric mechanical system for heating and conditioning, manually controlled by anyone with a thermostat placed inside the rooms. In any case there is a known people's complaint of how the upper level rooms are overheated from mid-spring till mid-autumn. And during the winter period the absence of an isolated roof concedes a heat loss through its surface. Heating and conditioning systems are inefficient, demanding a high energy consumption and supplying poor internal conditions in terms of temperature, air quality, CO2 percentage present on air.

- Introduce heating and conditioning automatic controls;
- Introduce automatic window openings to ventilate naturally rooms when air conditions are not optimal;
